Proven Success

Eagle Poly-V™ on a Roller Conveyor

Distribution Center

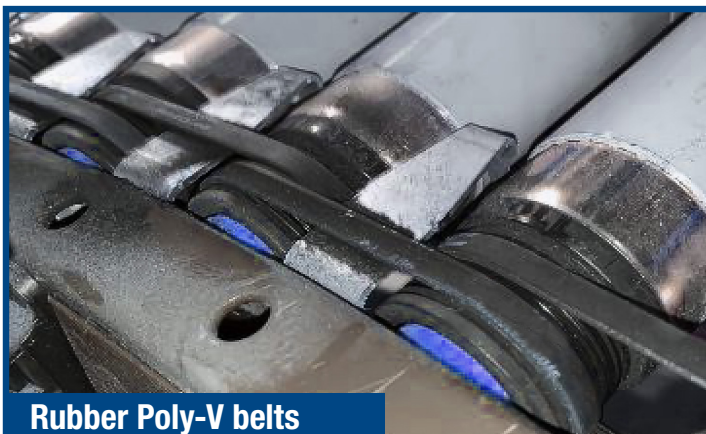
1. There were 317 rubber Poly-V belts replaced during the 4 month testing period.
2. Belt degradation and poor performance caused excessive downtime with both straight and angled rollers.
3. Rubber belts wore and became lodged around the roller and grooves causing damage and failure to the roller.
4. Debris build up in the roller grooves resulted in the Poly-V tracking off the pulley.
5. Rubber belts required installation with a high belt tension causing damage to some of the belts.

1. There were 0 Eagle Poly-V belts replaced during the 4 month testing period.
2. Fenner Drives Eagle Poly-V belts have been in the same application with no degradation.
3. Eagle Poly-V has no signs of damage or wear and did not become lodged around the roller and grooves.
4. No belt flaking or debris build up, Eagle Poly-V stayed on track in the groove.
5. Generous tension tolerance resulted in no belt damage during installation.
